**Appendix D2b. Response to Landfill Comments VR 2 and VR 9  
on the Draft Scientific Review of Biological Resources  
Impacts and Proposed Mitigation for the Potrero  
Hills Landfill Phase II Expansion  
(BCDC Permit No. MD88-09)**

Date: April 12, 2007

RE: Response to Comments VR2 and VR9 from the Scientific Review of Biological Resources Impacts and Proposed Mitigation for the Potrero Hills Landfill Phase II Expansion (BCDC Permit No. MD88-09)

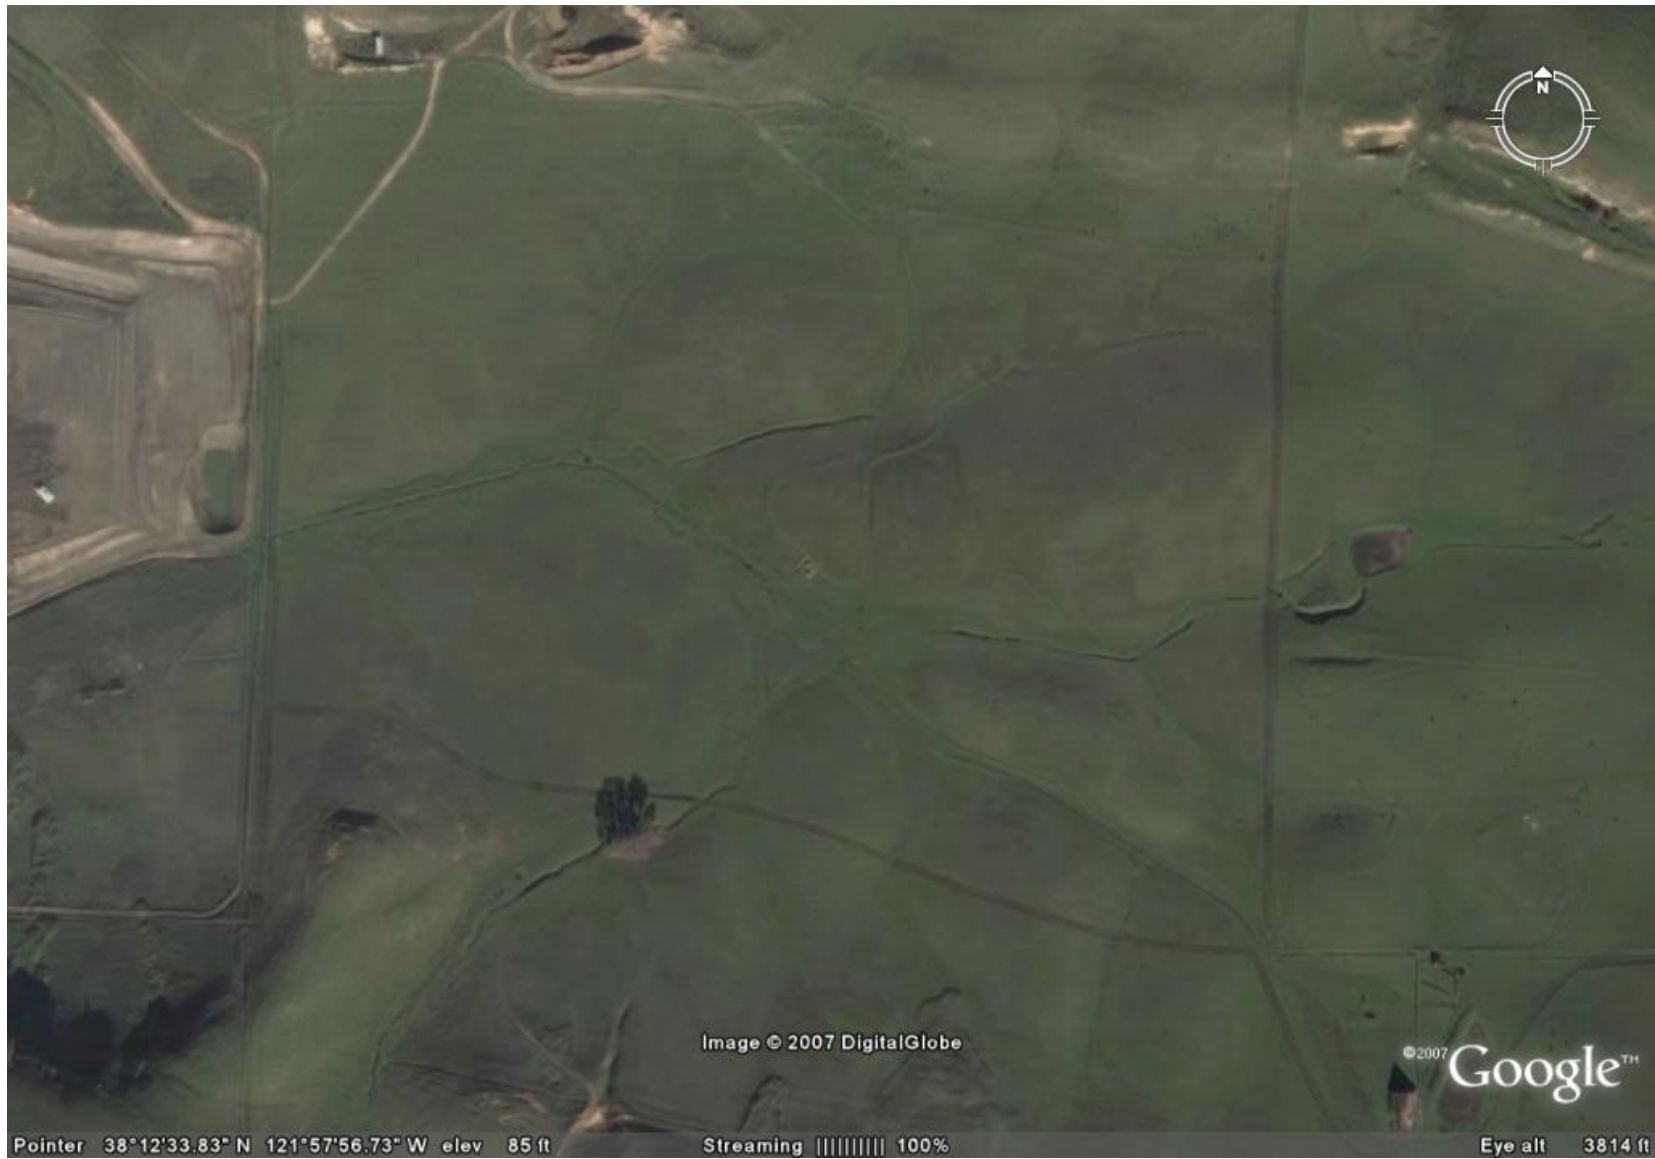
**Figure D2b-1. Google Spring Branch Creek Photograph**

(b) Aerial photography: To investigate current aerial photography, I downloaded a photo of the Phase II area which I’ve attached to this response (see Figure D2b-1). A darker green continuous drainage and tributaries are visible in the air photo. This pattern corresponds to Spring Branch Creek as mapped by the USGS. And, in the air photo a channel bed and banks are visible, which meets the definition of a stream channel in the Swanson Assessment.
